UNDERWATER BRIDGE INSPECTION REPORT

STRUCTURE NO. 92052

NORTH FORK CROW RIVER

MINNESOTA DEPARTMENT OF TRANSPORTATION
UNDERWATER BRIDGE INSPECTION

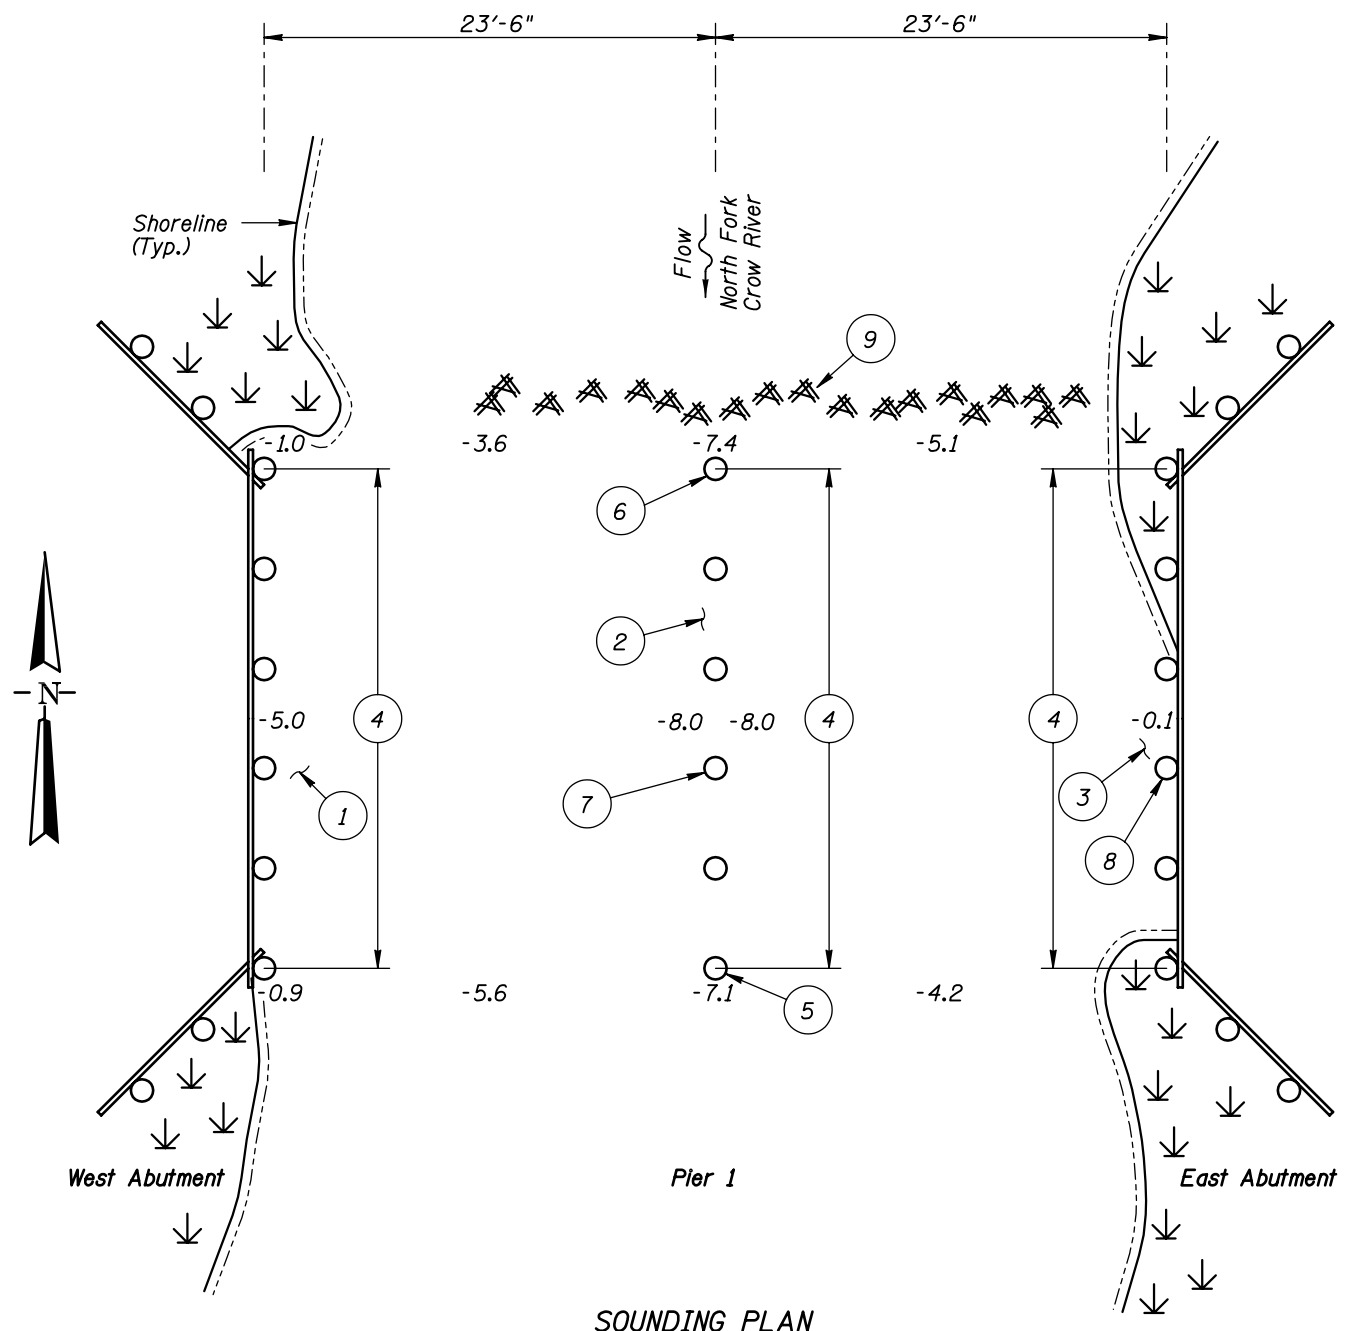
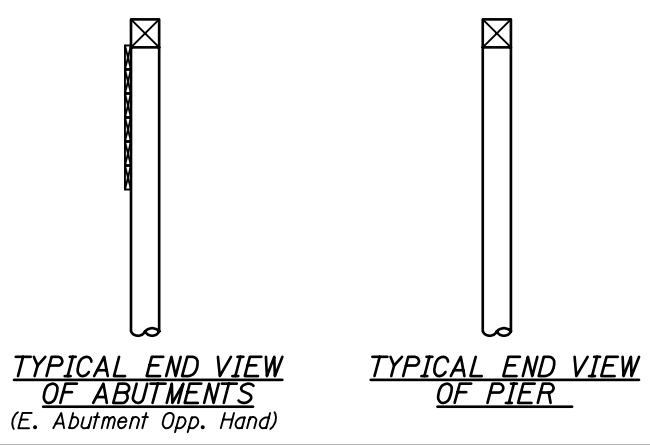
| INSPECTION AND SOUNDING PLAN | | |

- 1 The channel bottom at the West Abutment consisted of cobbles and silt with up to 6 inches of probe rod penetration.
- 2 The channel bottom at Pier 1 consisted of soft silt with up to 1.5 feet of probe rod penetration.

- 3 The channel bottom at the East Abutment consisted of cobbles and silt with up to 1 foot of probe rod penetration.
- 4 All timber piles exhibited approximately 5 percent section loss near the waterline with up to 1/8 inch wide vertical outer shell cracking extending the full height of the piles with penetrations up to 1/4 inch deep near the waterline.

- 5 The diagonal brace was broken/split below the waterline and was no longer engaged to the downstream pile at the pier. Overall, split was 5 to 6 feet long.

- 6 The diagonal brace was broken below the waterline and was no longer engaged to the upstream pile at the pier.
- 7 The diagonal brace was broken below the waterline and was no longer engaged to the pile at the pier.

- 8 The timber pile exhibited decay, delamination, and outer shell cracking from 2 feet above the waterline to the channel bottom with up to 2 inches of penetration.

- 9 A moderate to heavy accumulation of timber debris, including 2 foot diameter logs, was observed along the entire upstream fascia.

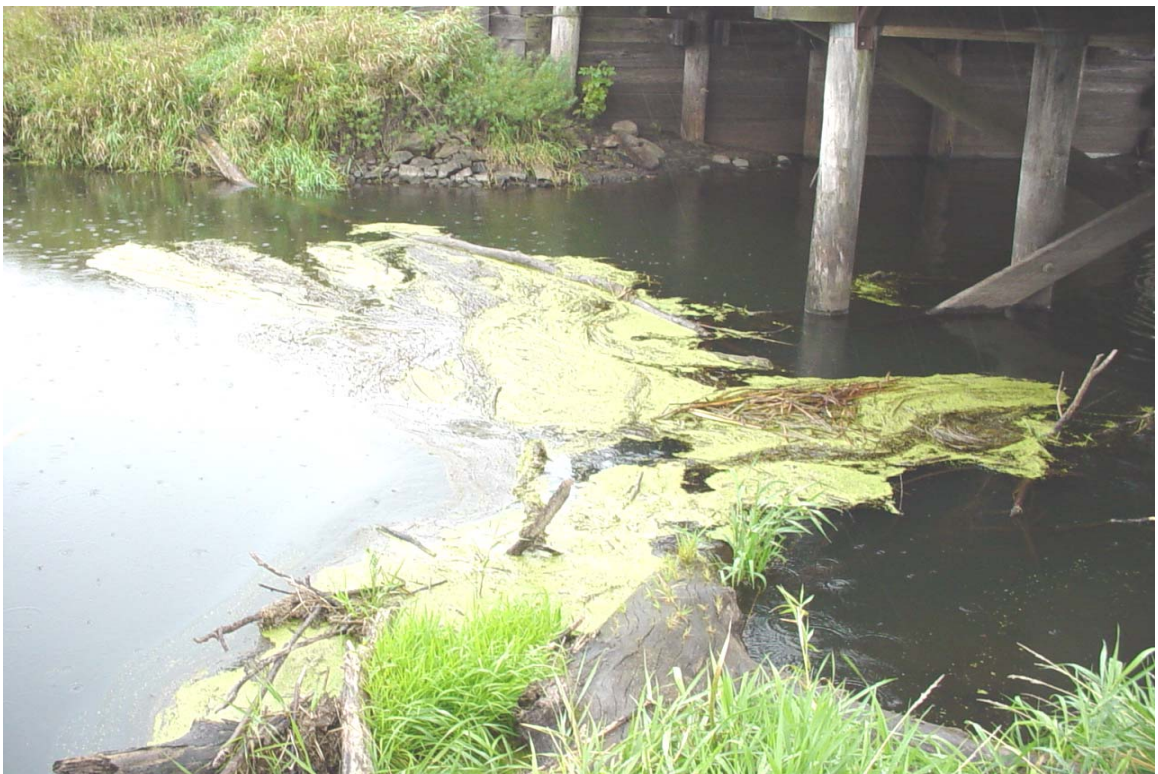
Photograph 4. View of the Timber Debris at the Upstream Fascia of the Structure, Looking East.

Remove the moderate accumulation of timber debris from the upstream fascia of the bridge during routine maintenance.

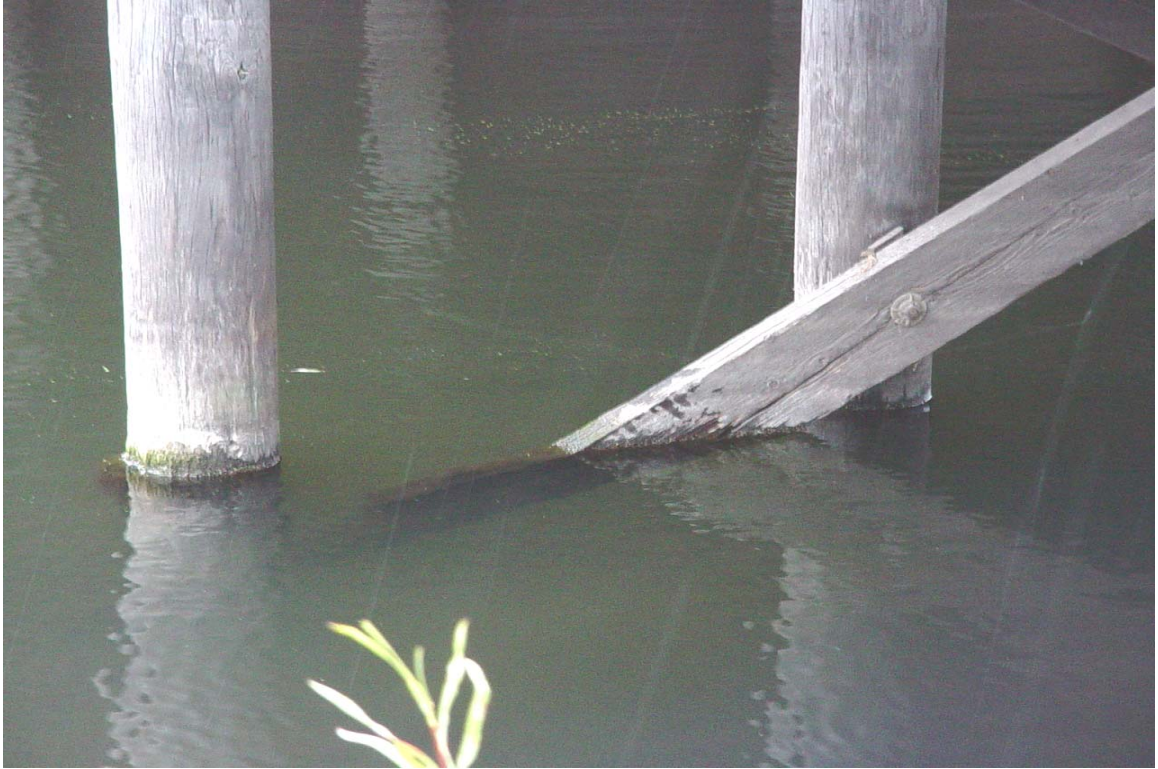
Photograph 5. View of the Broken Brace at the Downstream Pile of Pier 1, Looking West.

Replace the broken and/or split diagonal braces during future maintenance operations. Monitor the decayed piles at the East Abutment during future inspections, and if found to be progressing, remedial measures may then be warranted.

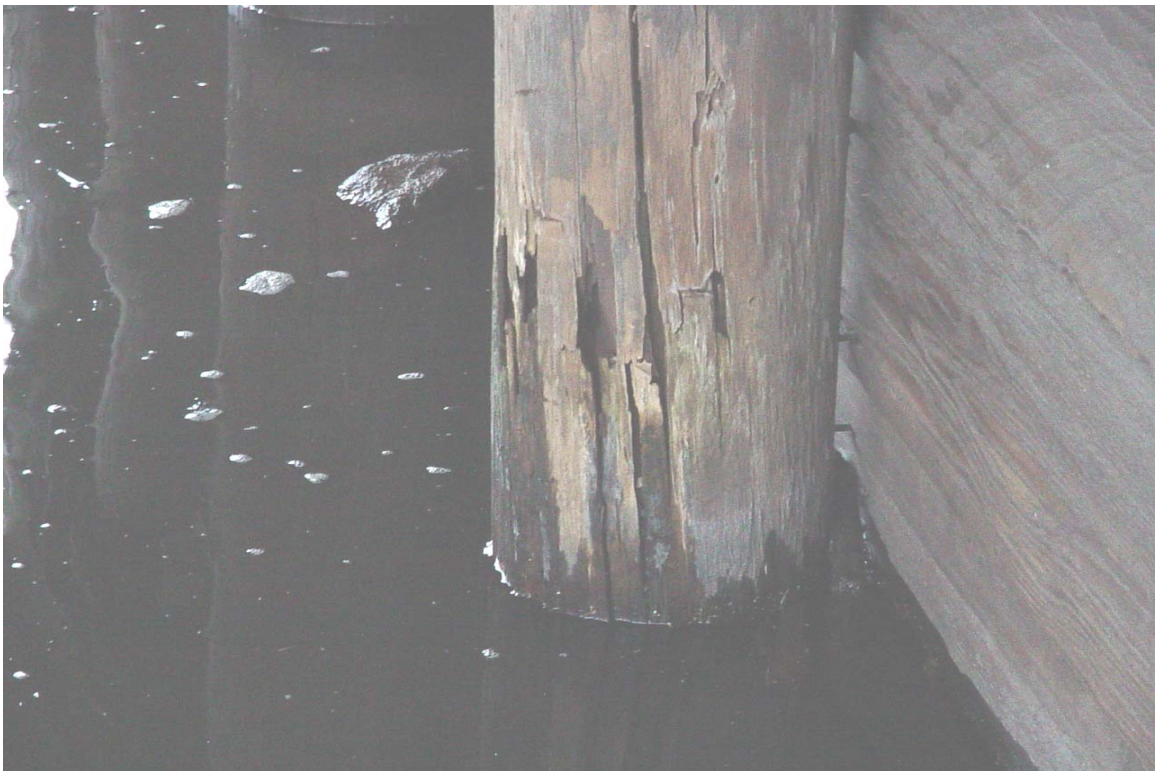
Photograph 6. View of the 4th Pile from the Upstream Fascia of the East Abutment, Looking North.
